Certificate of Conformance for Freight Container Mechanical Seal Testing Seal Classification: Indicative seal

TEST REPORT NO.: N0624153-T01

SUBJECT: Freight containers Mechanical seals classification Testing

Name of Article: Cable Seal 1.5mm

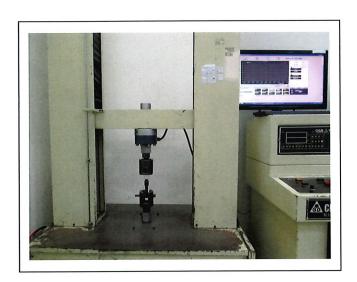
Testing Instrument: Universal Testing Machine (No.TG0103)

Universal Testing Machine

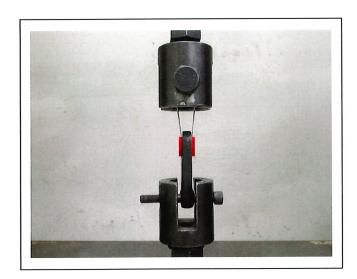
The seal was gripped in a tensile machine and a pull force applied.

Tensile Set up

Specimen No.	Requirement Load to failure	Result kN	Seal classification
01	10.0 kN: High security seal	3.74	Security seal (S)
02	2.27 kN: Security seal	3.93	Security seal (S)
03	< 2.27 kN: Indicative seal	3.51	Security seal (S)
04		3.94	Security seal (S)
05		3.92	Security seal (S)

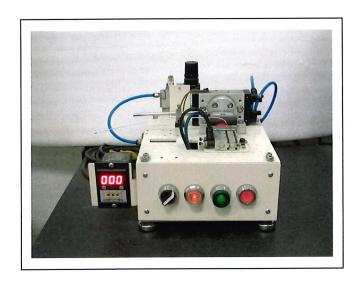
Fix the locking end and flex the material adjacent to this fixed end repeatedly through an arc of 180° until failure

Bend Set up

Complemental No.	Requirement	Result	Seal classification
Specimen No.	Cycles to failure	Cycles	
11	501: High security seal	< 251	Indicative seal (I)
12	251: Security seal	< 251	Indicative seal (I)
13	<251: Indicative seal	< 251	Indicative seal (I)
14		< 251	Indicative seal (I)
15		< 251	Indicative seal (I)

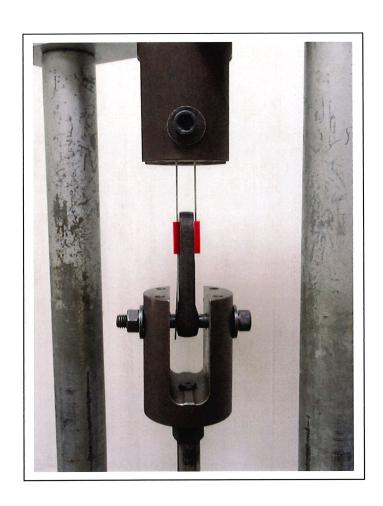
The impact test is performed at 18 degrees C and minus 27 degrees C of temperature. The impact load is applied at the locking mechanism of the seal in the direction opposite the direction used in locking the seal.

Impact Set up

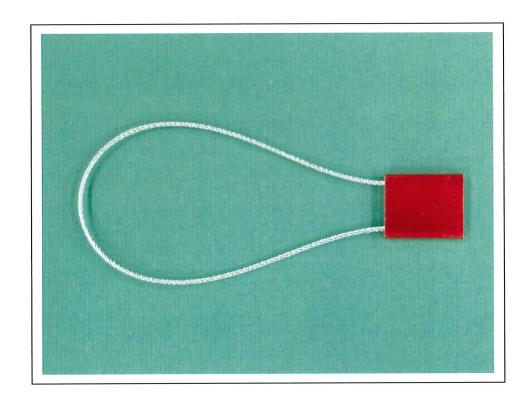
Name of Article: Cable Seal 1.5mm

Type: BC-C203
